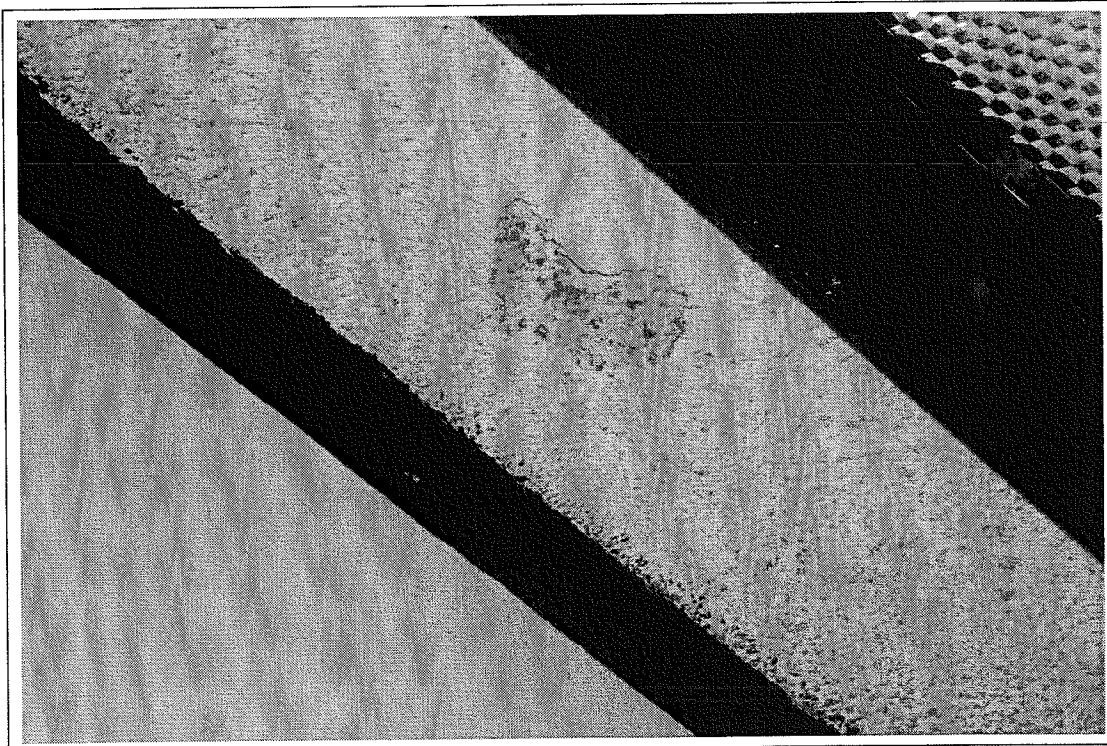
Photo 24. 1st floor auditorium - damaged acoustical plaster above stage

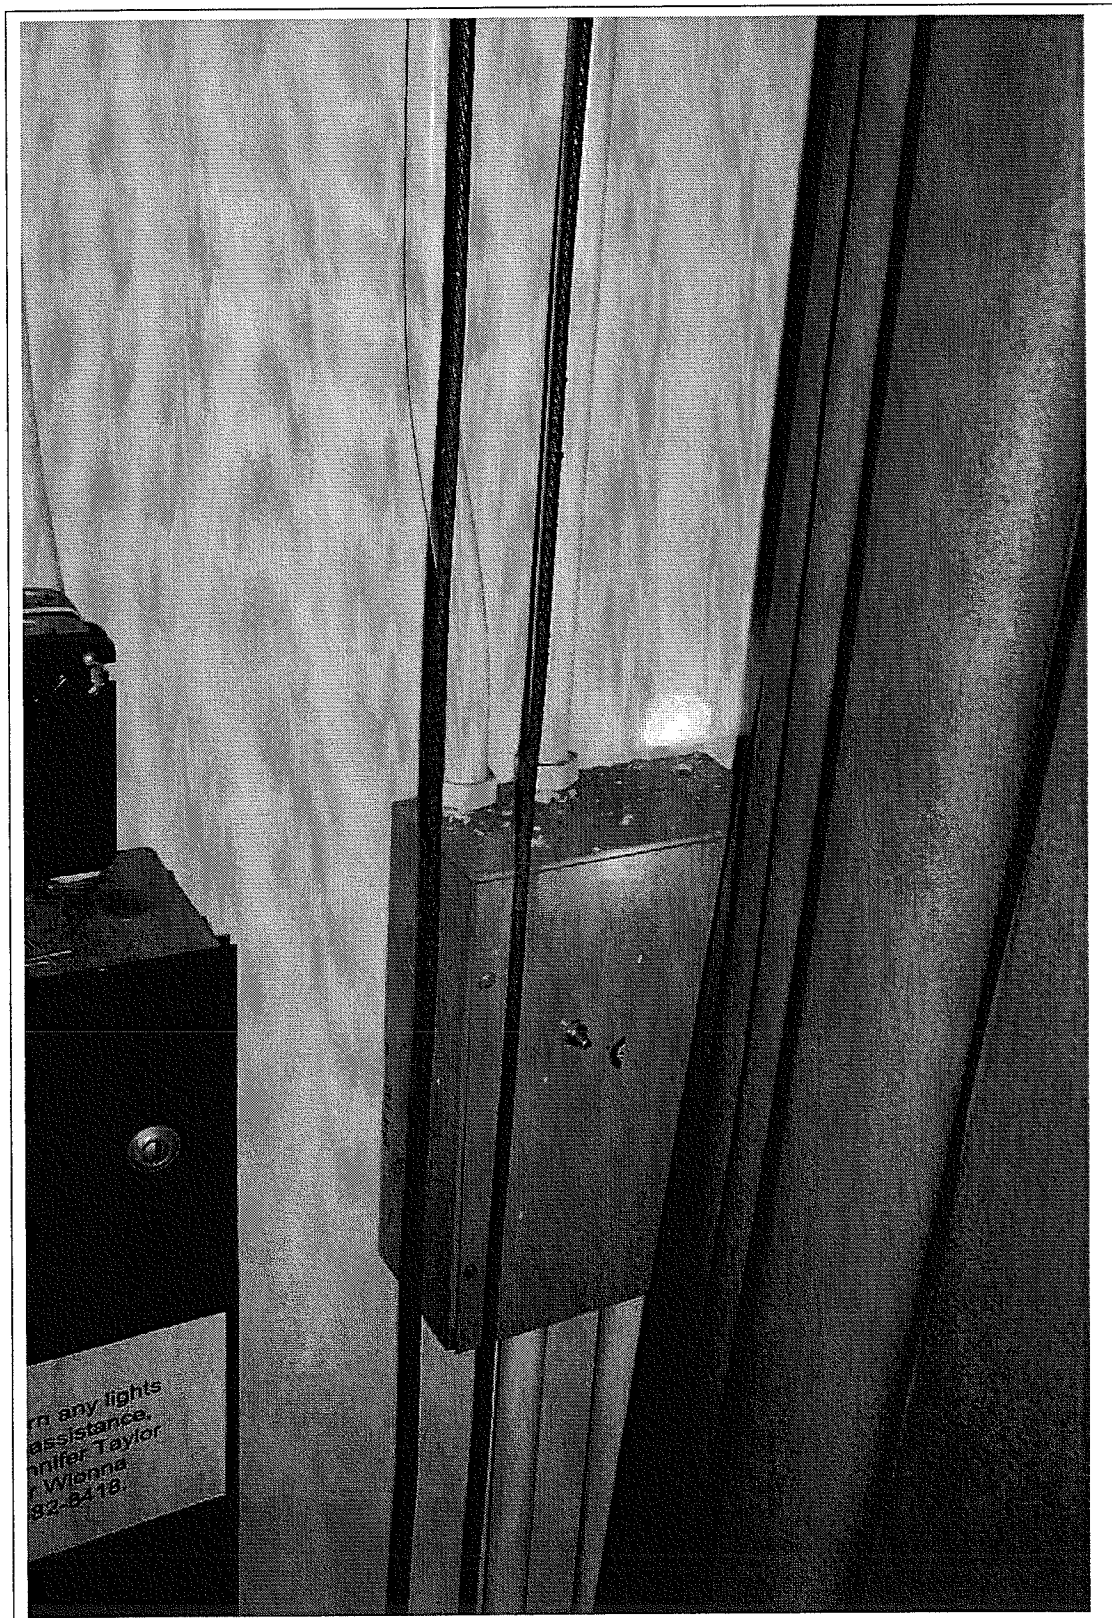
Photo 25. 1st floor auditorium - General view of stage curtains adjacent to breaker box
(general location of dust sample #1)

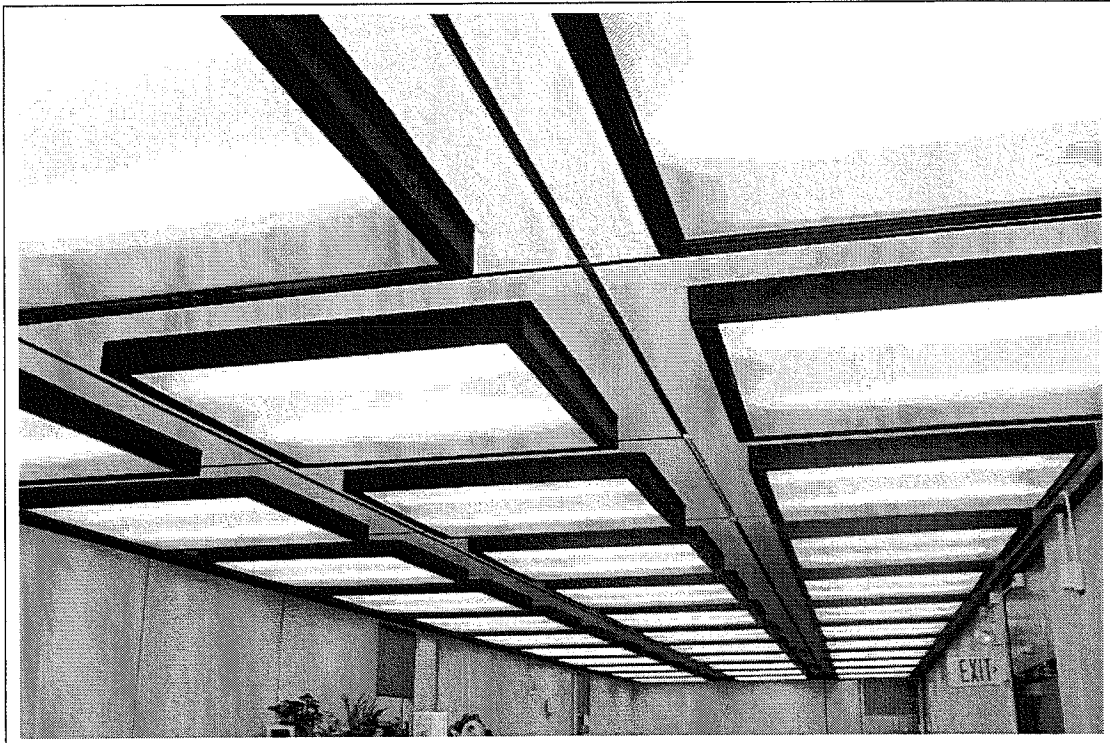
Photo 26. 4th floor elevator lobby - General view of acoustical plaster in lobby

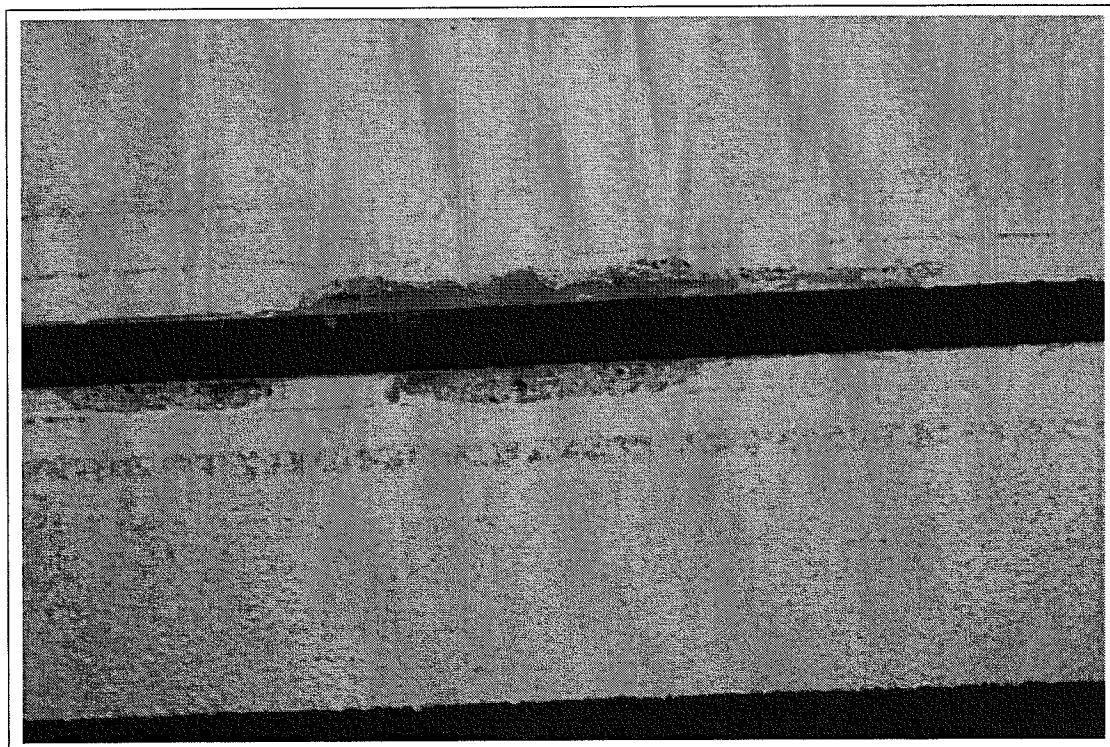
Photo 27. 4th floor, SW corner hallway - Close-up of damaged acoustical plaster on 4th floor south side
